**METALS RESEARCH LABORATORY
CARNEGIE INSTITUTE OF TECHNOLOGY**

**Stress-Corrosion Cracking Behavior
of an 18% Ni Maraging Steel**

A. J. Stavros^{*} and H. W. Paxton

April 1970

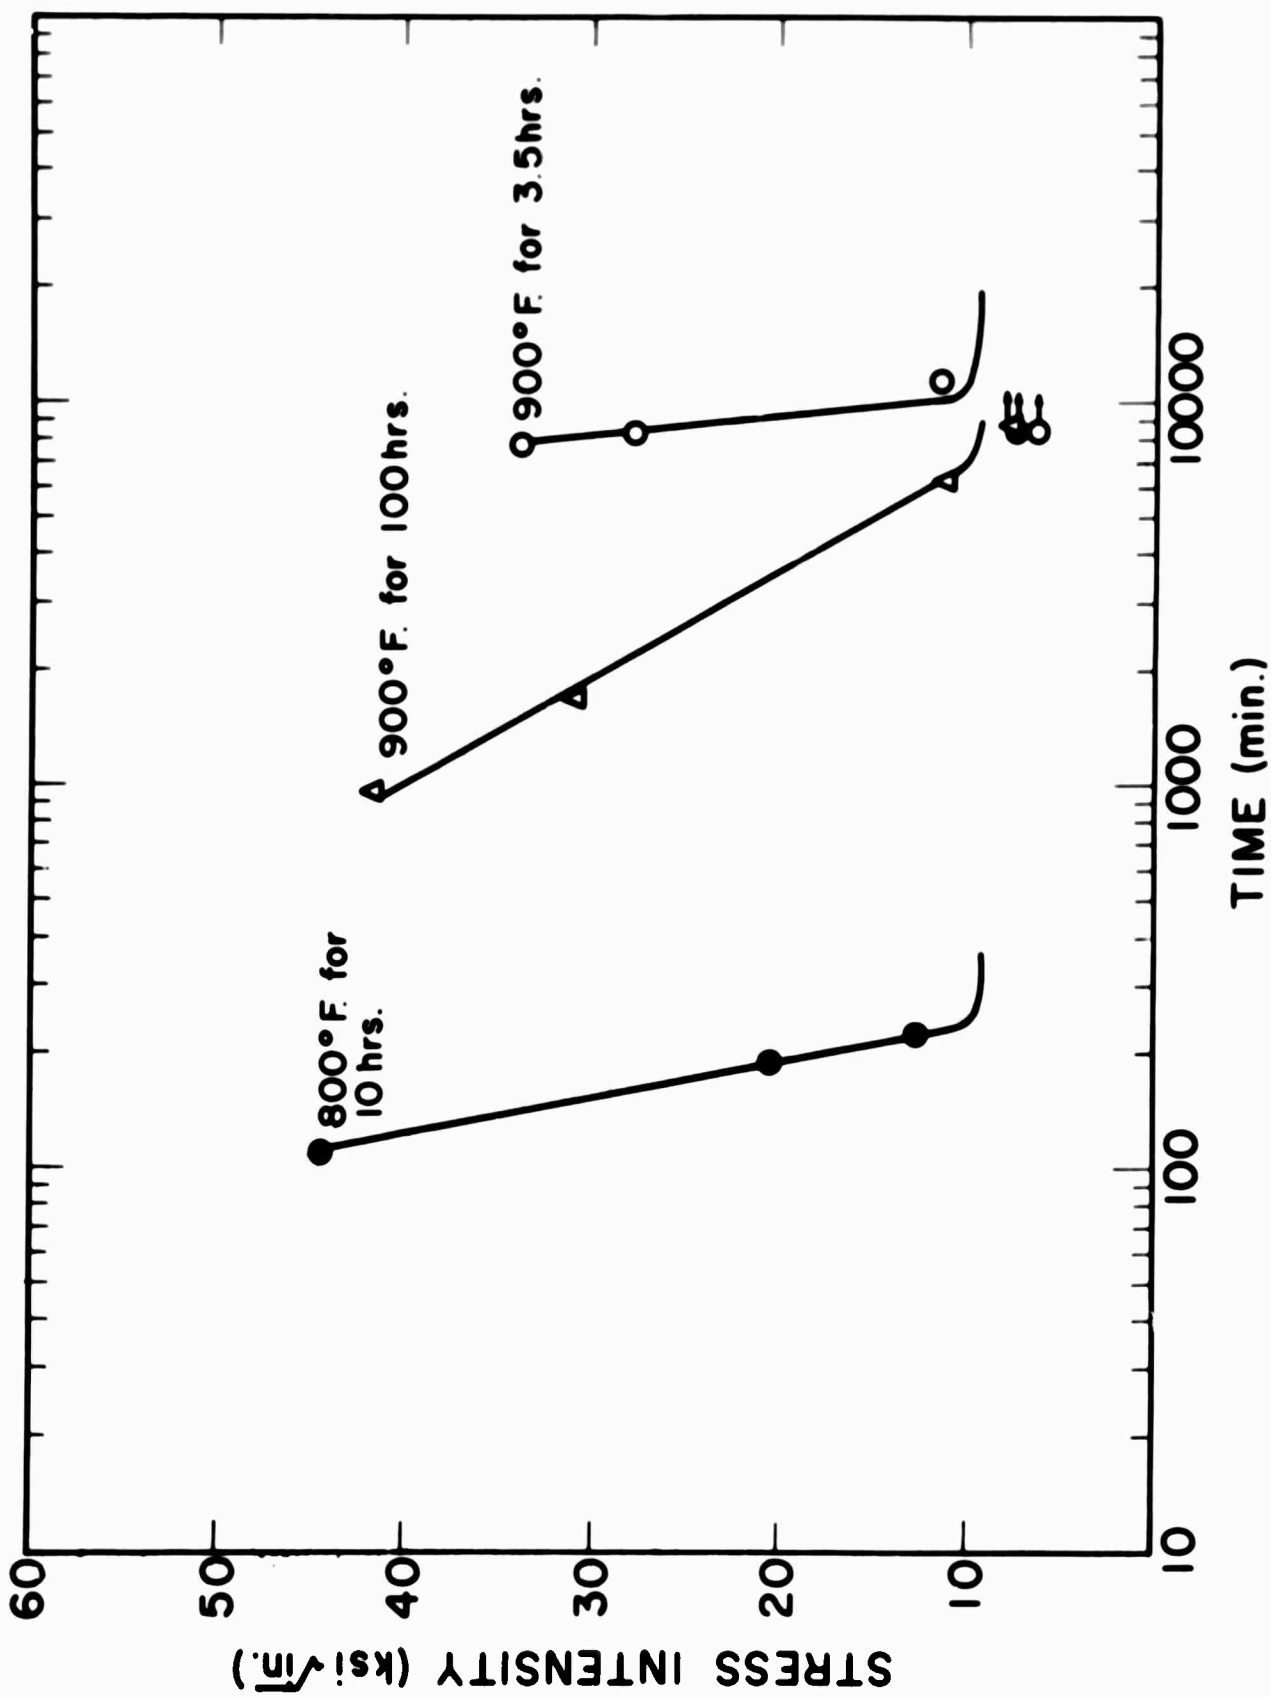
Fig. 2. Effect of Aging Treatment on Stress-Corrosion Susceptibility in 3% NaCl at pH 6.3 of 18% Ni Maraging Steel Austenitized 2 hrs. at 1500°F.

Figure 2 illustrates the cracking behavior in deaerated 3% NaCl at pH 6.3 of maraging steel annealed at 1500°F and aged. The time to failure appears relatively insensitive to stress intensity but very dependent on aging treatment. K_{Isc} has a value of approximately 10-15 Ksi/in. for all three aging treatments. When the pH of the salt solution is changed to 1.7 the same type of behavior is observed (Figure 3). K_{Isc} is still 10-15 Ksi/in.

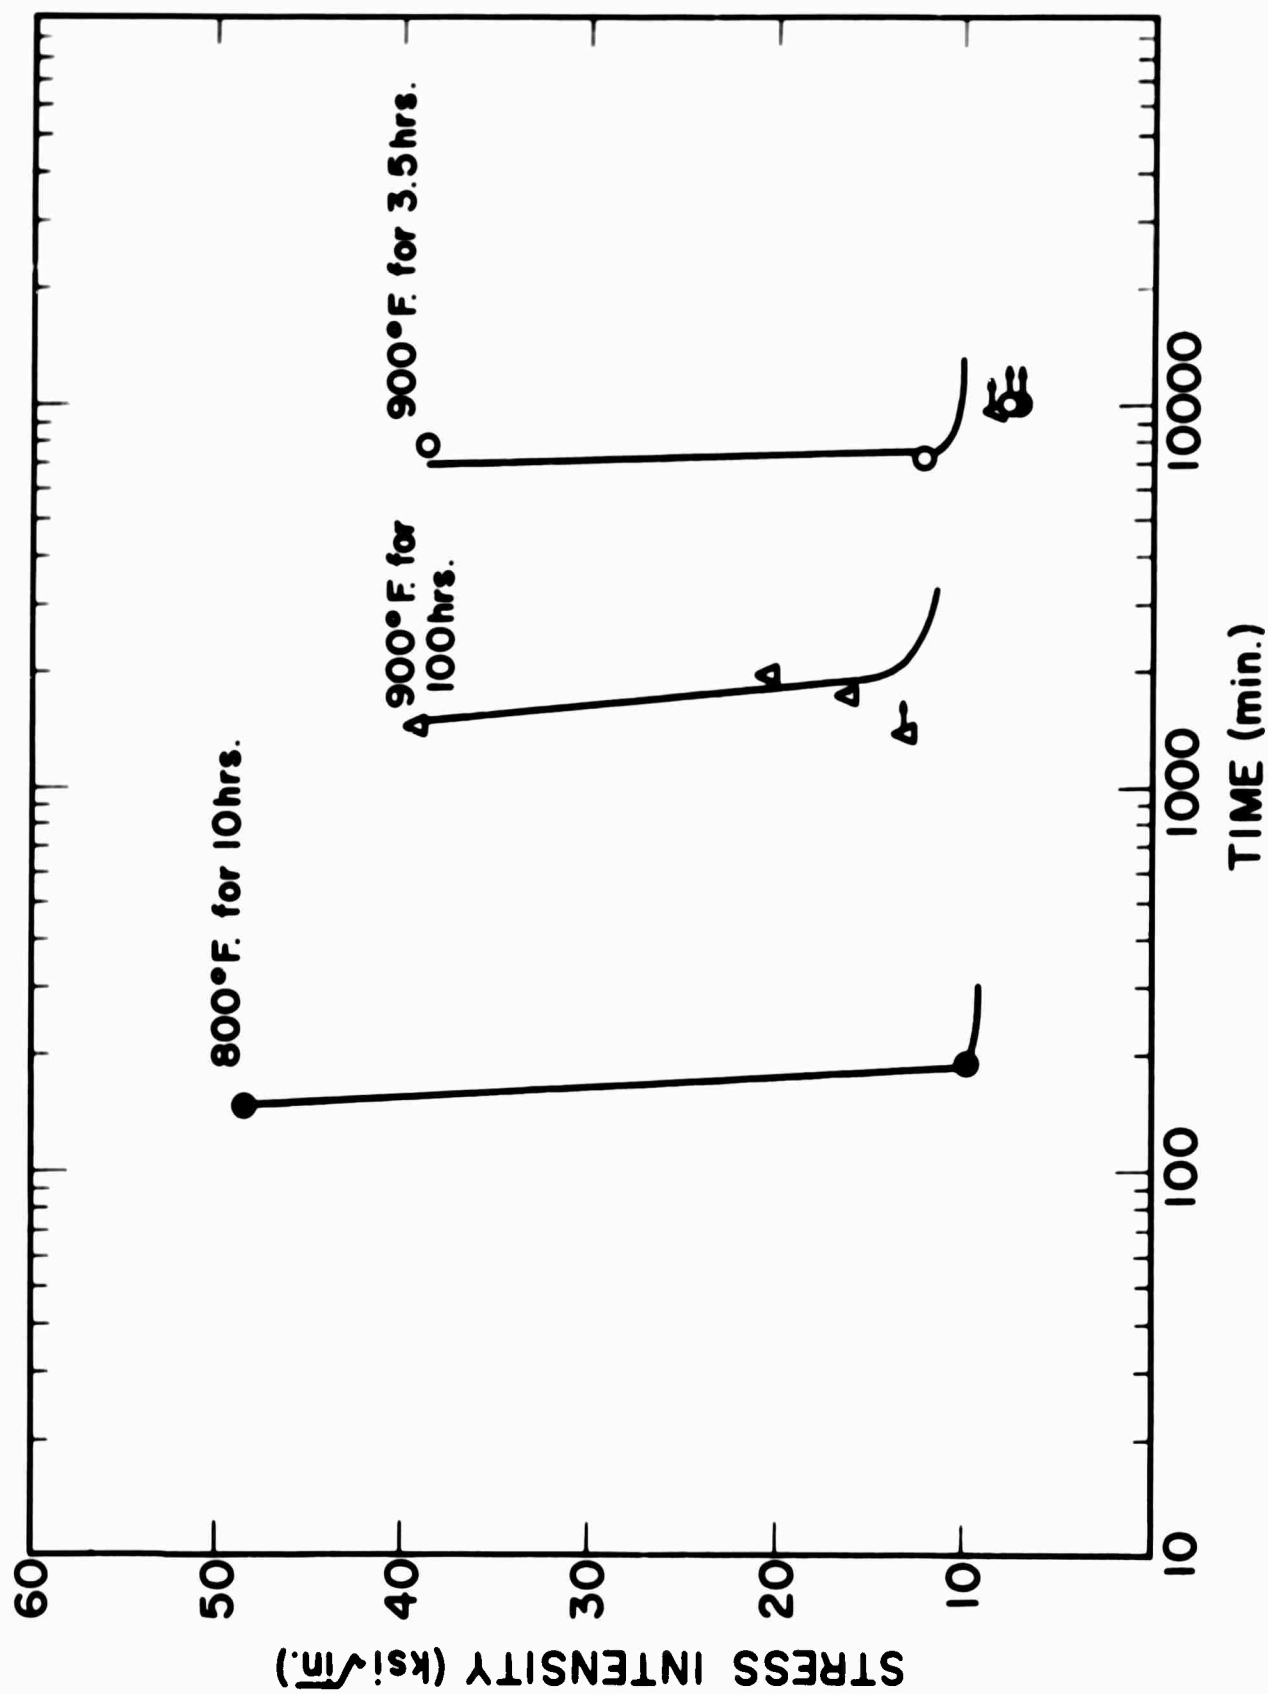
Fig. 3. Effect of Aging Treatment on Stress-Corrosion Susceptibility in 3% NaCl at pH 1.7 of 18 Ni Maraging Steel Austenitized 2 hrs. at 1500° F.

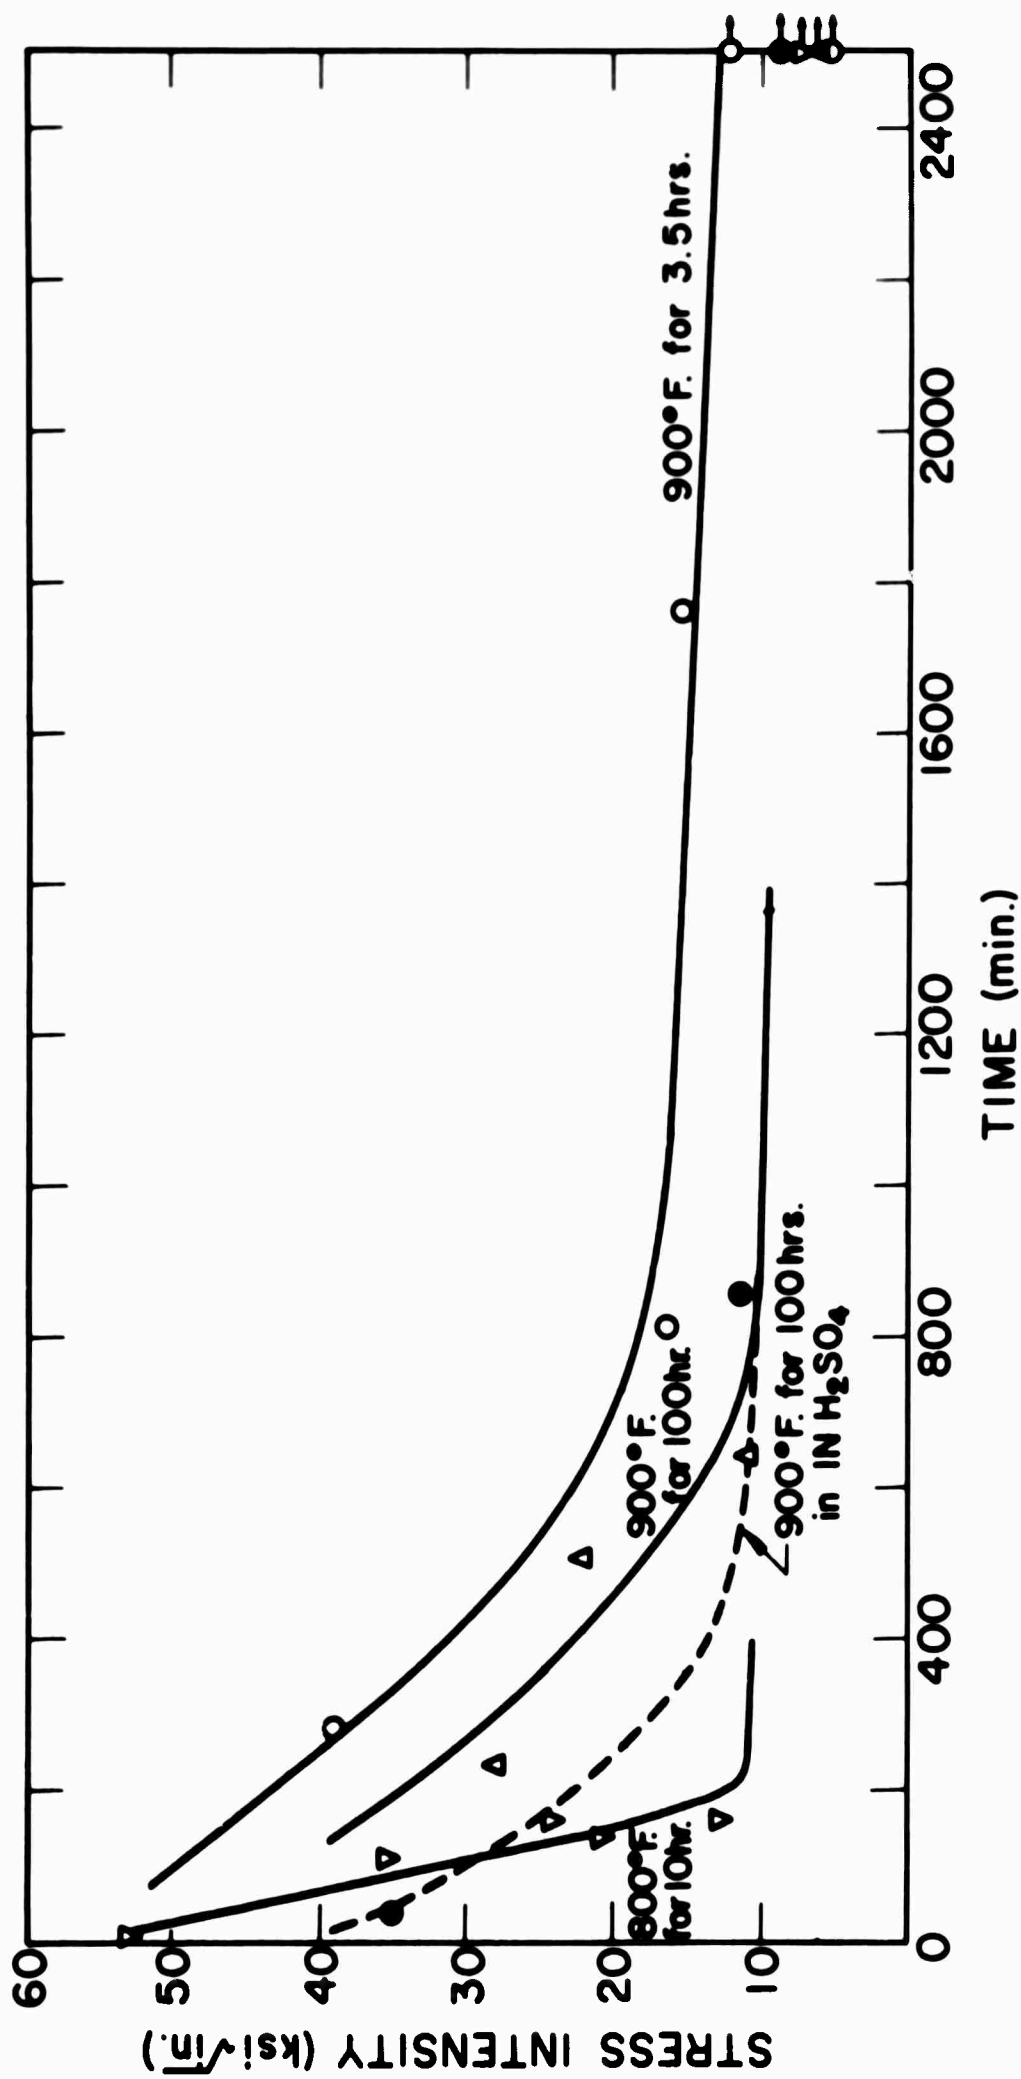
Fig. 4. Effect of Aging Treatment on Stress-Corrosion Susceptibility in 3% NaCl at pH 6.3 of 18% Ni Maraging Steel Austenitized 1 hr. at 2300°F + 4 hrs. at 1700°F.

Figure 4 and Figure 5 illustrate the cracking behavior in deaerated 3% NaCl of pH 6.3 and pH 1.7 respectively of maraging steel annealed at 2300°F + 1700°F and aged. Time to failure appears much more dependent on stress intensity and appreciably less so on aging treatment. K_{Isc} , however, still has a value of 10-15 Ksi/in.

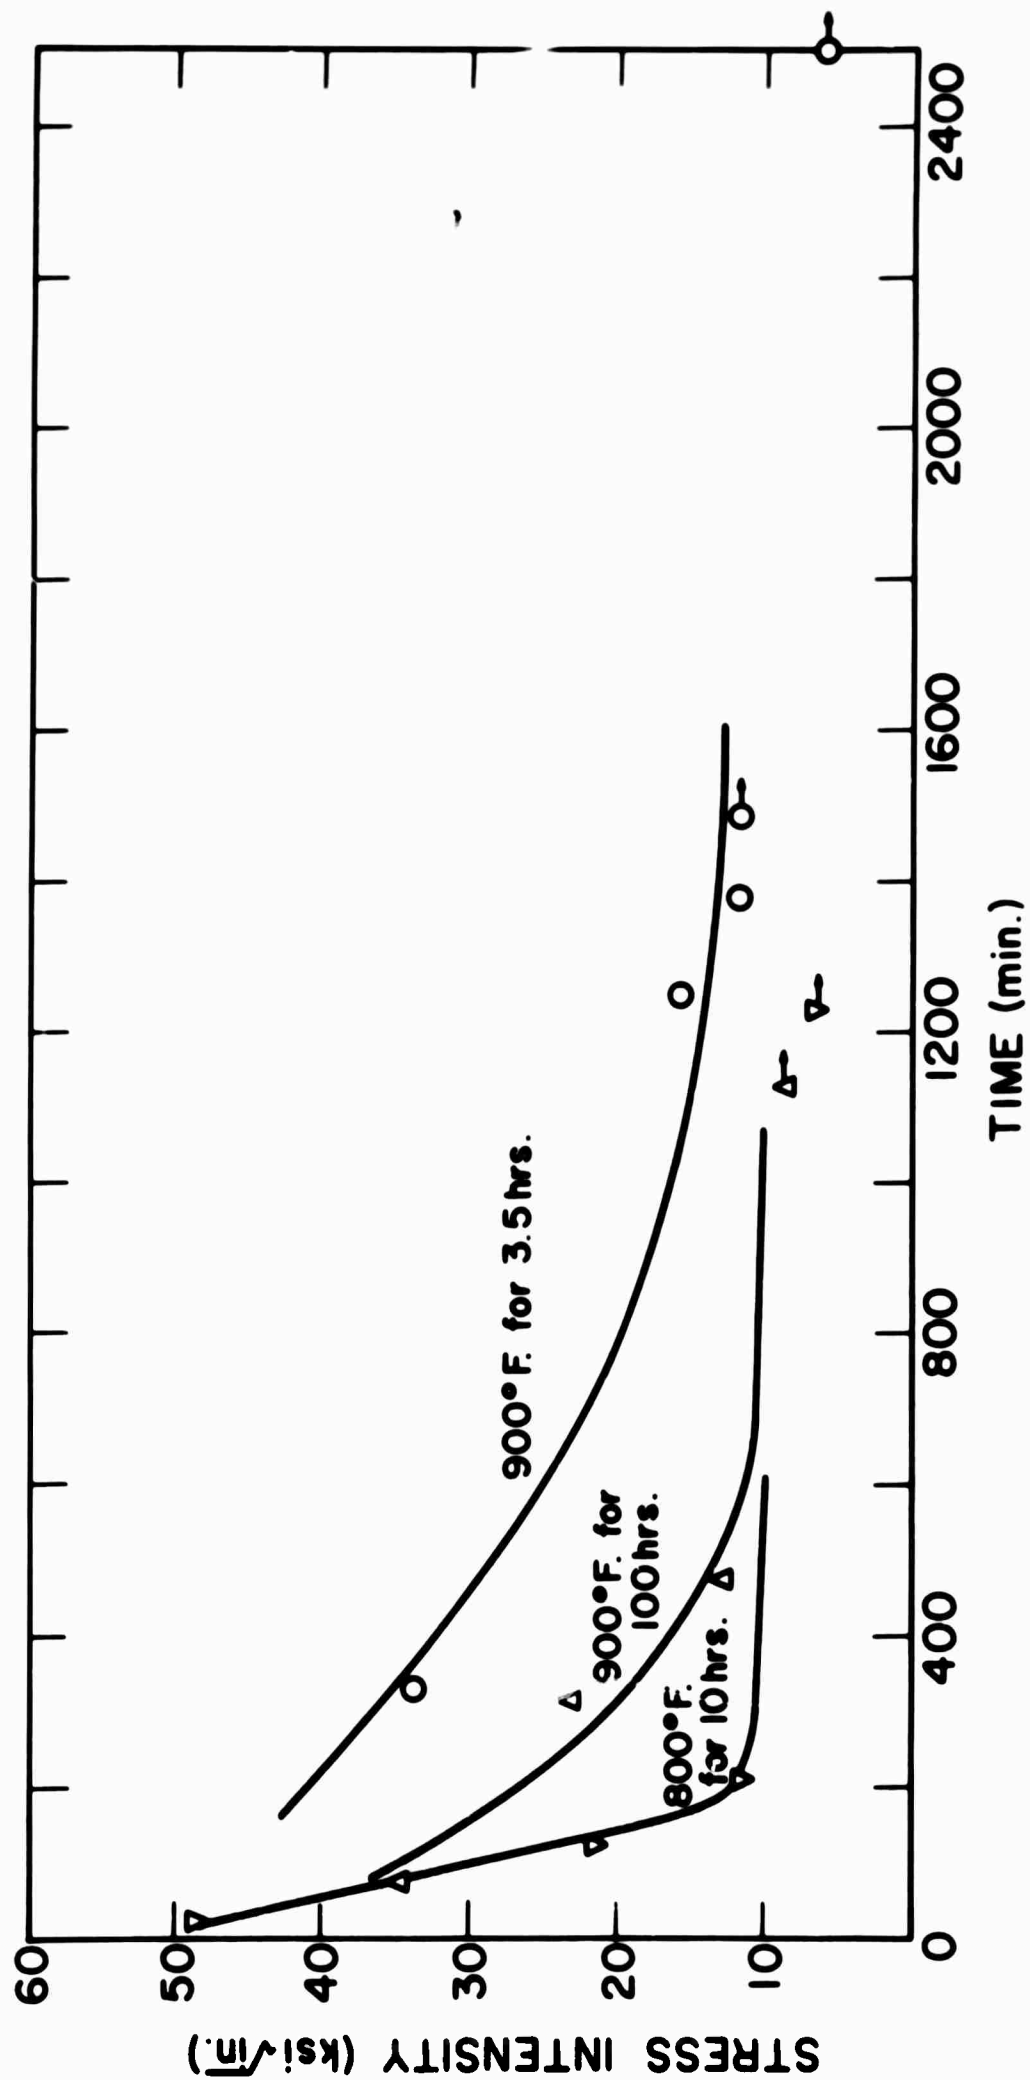
Fig. 5. Effect of Aging Treatment on Stress-Corrosion Susceptibility in 3% NaCl at pH 1.7 of 18% Ni Maraging Steel Austenitized 1 hr. at 2300°F.

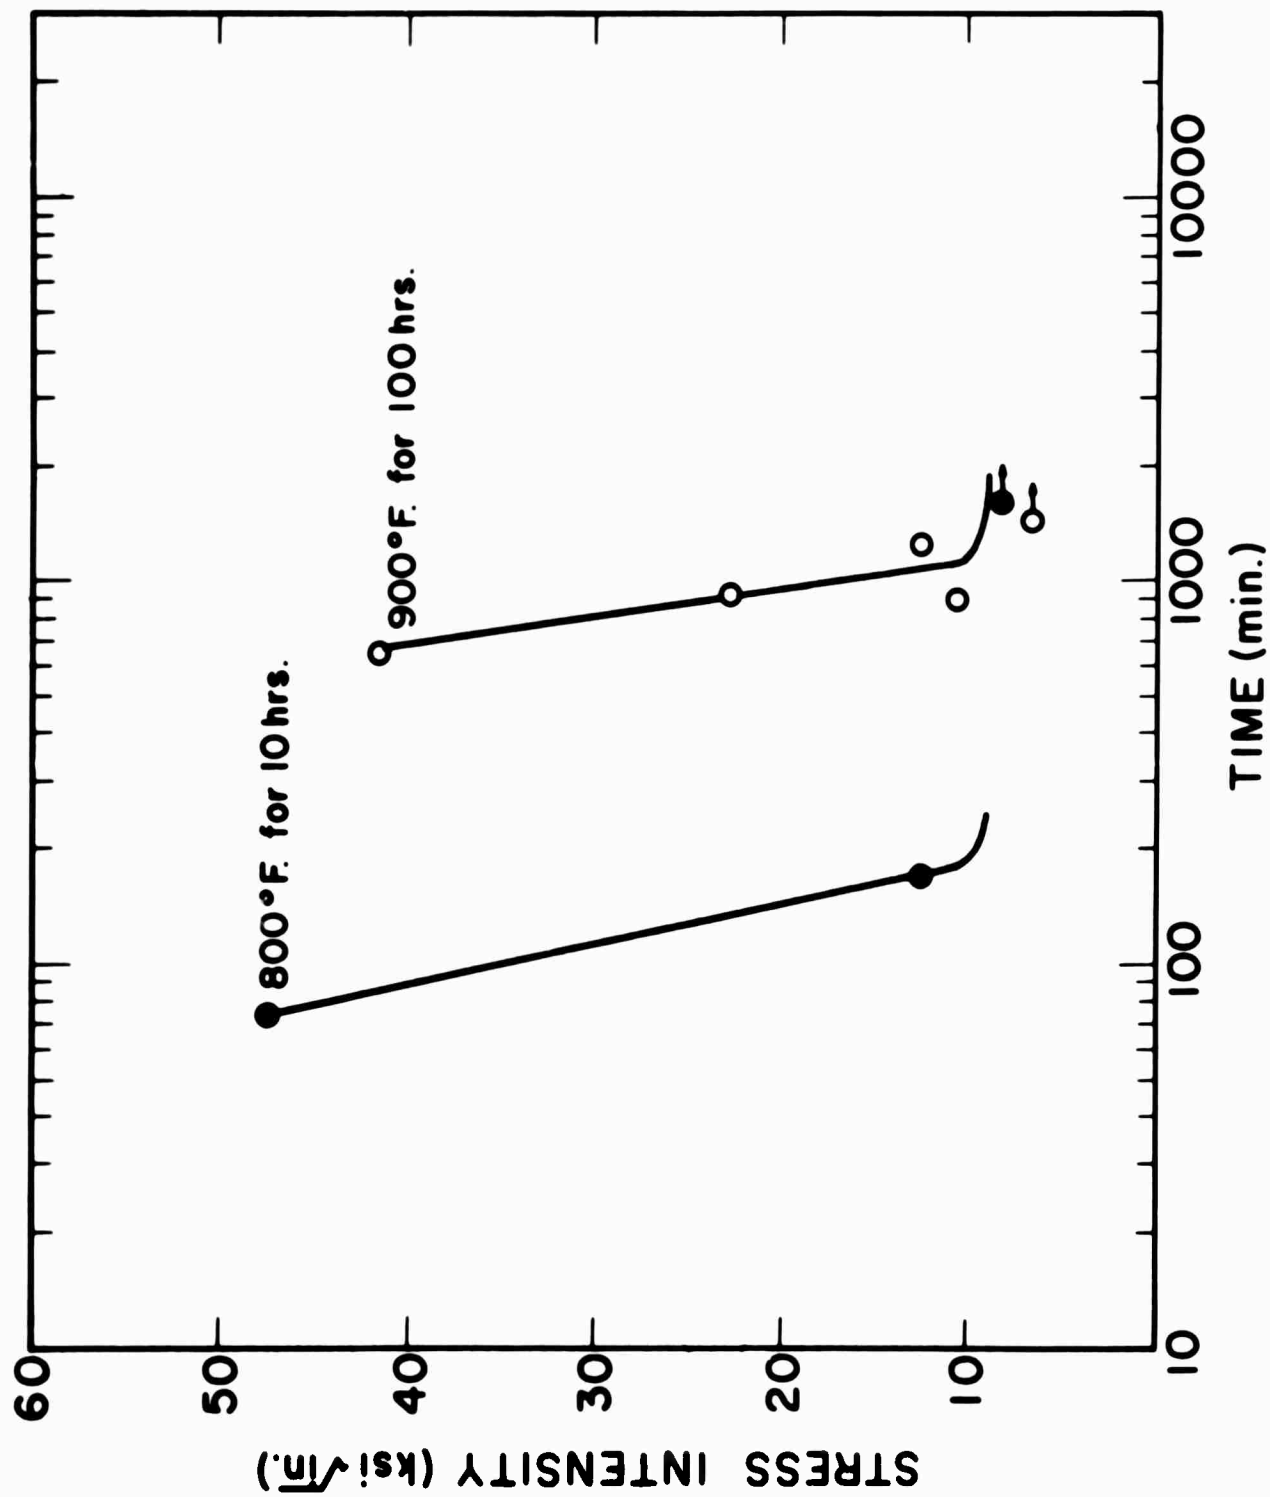
Fig. 7. Effect of Aging Treatment on Stress-Corrosion Susceptibility in
IN H₂SO₄ of 18% Ni Maraging Steel Austenitized 2 hrs. at 1500°F.

intensity-failure time plots were similar to those obtained in 3% NaCl for material given equivalent heat treatments (Figure 7). Branching was also observed in specimens given the 1500°F annealing treatment.

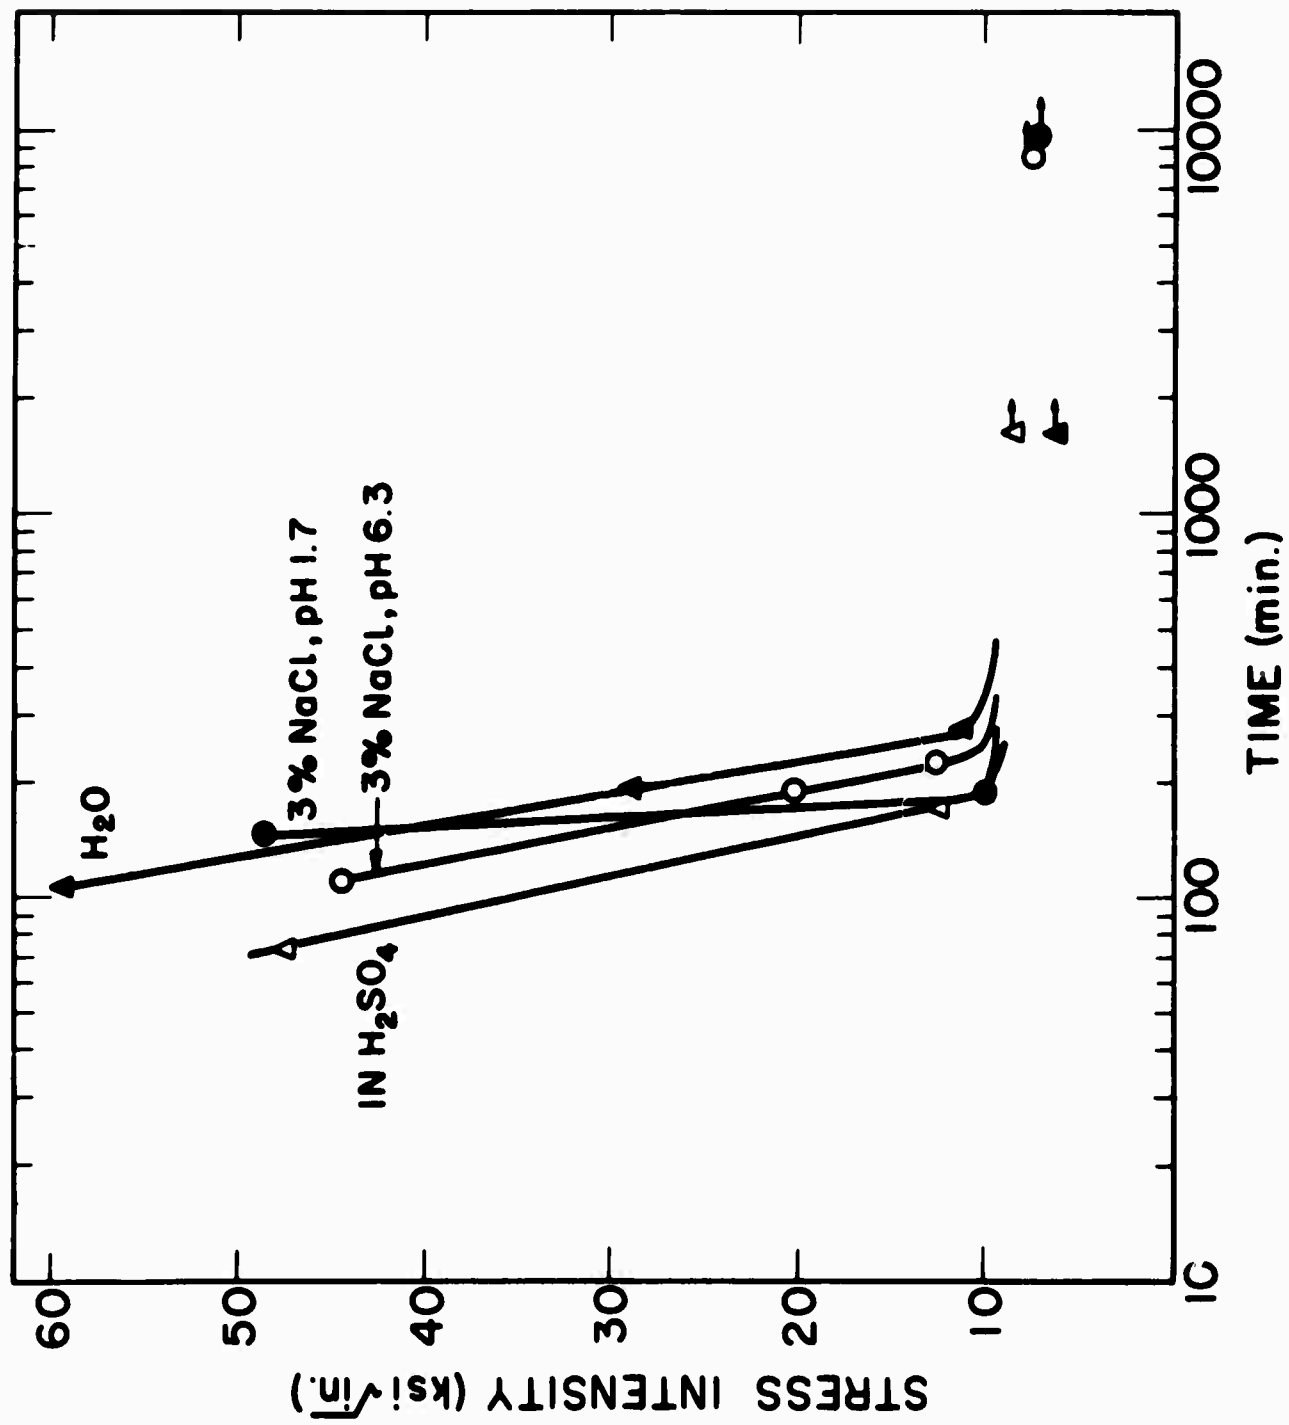
Fig. 8. Effect of Environment of Stress-Corrosion Susceptibility of 18% Ni Maraging Steel Austenitized 2 hrs. at 1500°F and Aged 10 hrs. at 800°F.

Deaerated distilled water was also used as a test environment. The resulting stress intensity-failure time curves were similar to those obtained in the salt and acid solutions. Figure 8 presents a comparison of cracking behaviors in distilled water, sulfuric acid, and sodium chloride for a single heat treatment. The stress intensity dependence and the threshold stress intensity appear unaffected by environment.

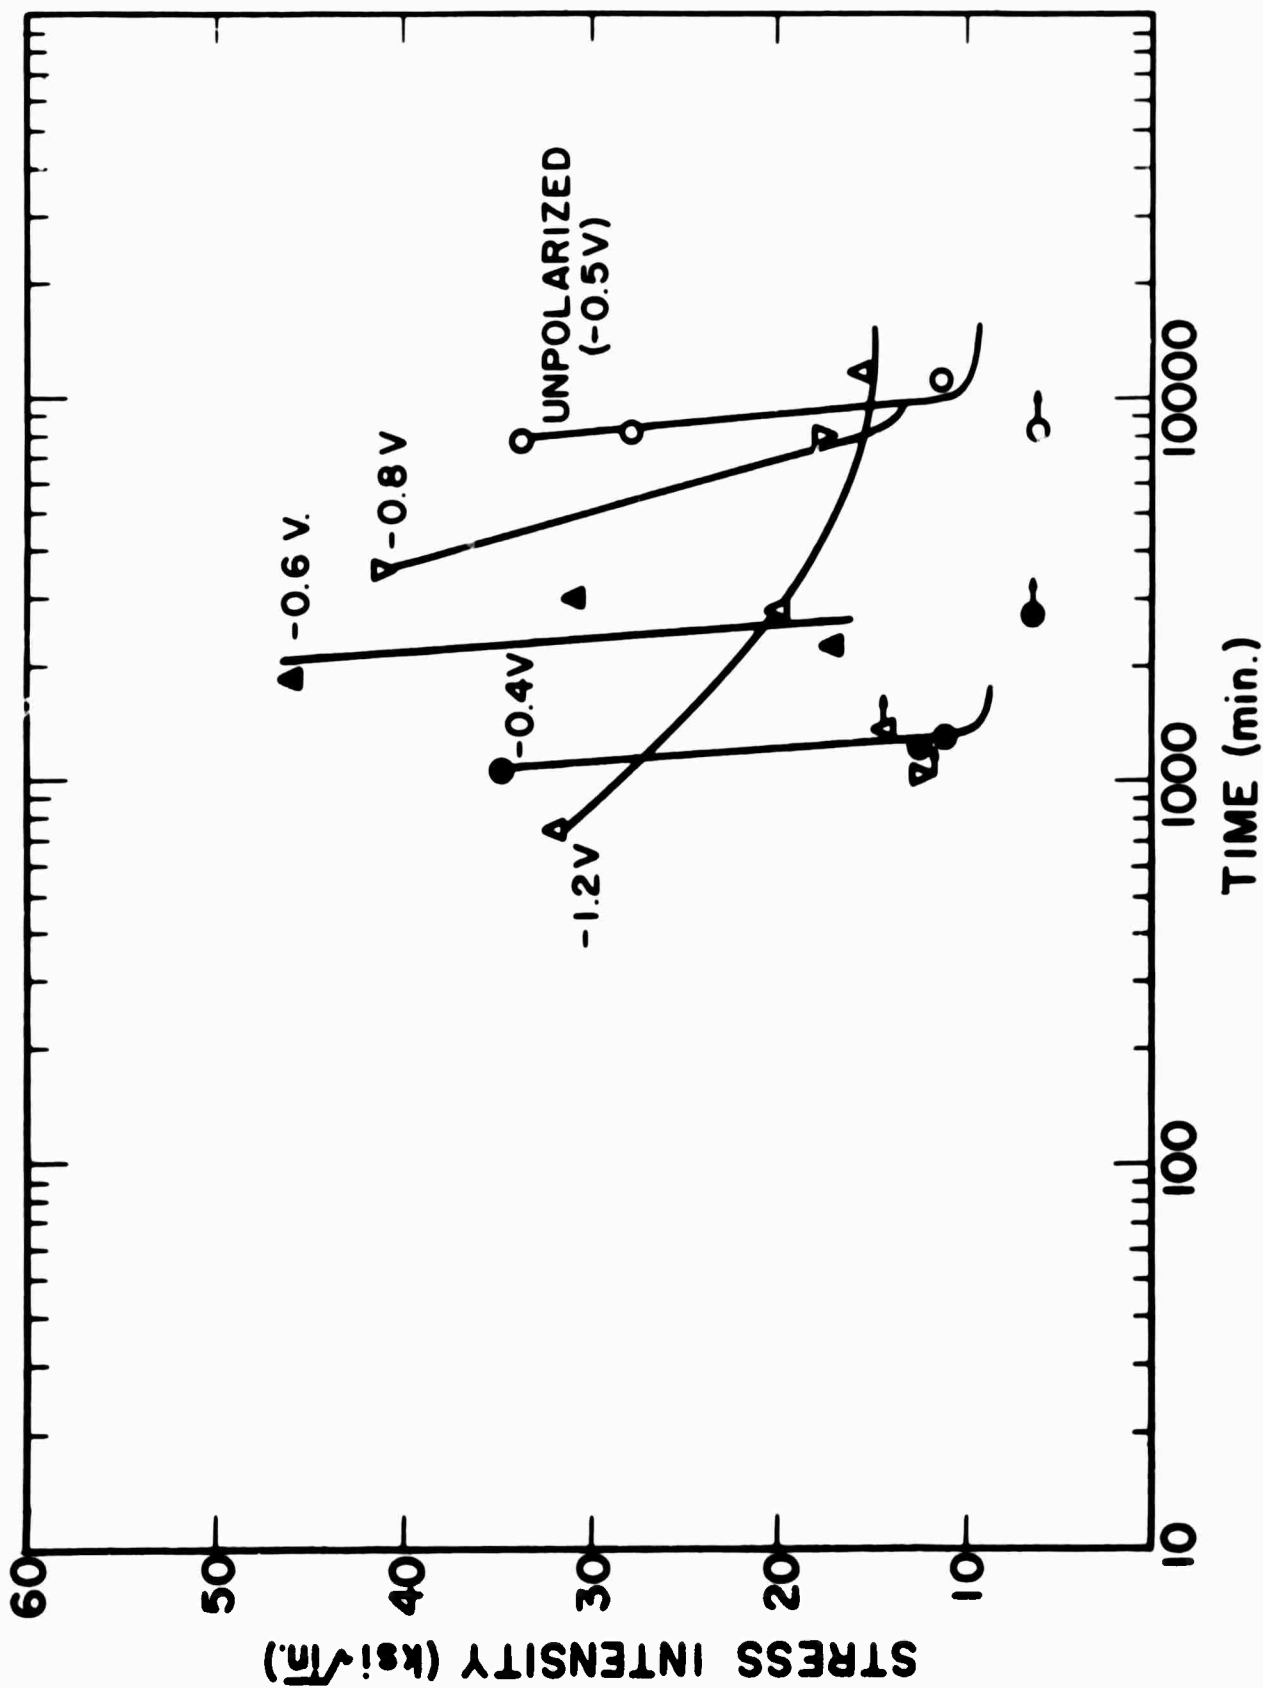
Fig. 9. Effect of Applied Potential on Stress-Corrosion Susceptibility of 18% Ni Maraging Steel Austenitized 2 hrs. at 1500° F and Aged 3 1/2 hrs. at 900° F.

Most previous investigations on stress-corrosion cracking of martensitic steels have relied on electrochemical concepts to suggest the controlling mechanism. The effect of potential on cracking behavior in 3% NaCl of pH 6.3 for one heat treatment is shown in Figure 9. All applied potentials lower t_f with respect to the unpolarized condition at all K_{II} . Thus the electrochemical means of distinguishing between possible mechanisms¹¹ does not yield valid results. K_{Isc} , however, does not appear to be measurably affected by applied potential.

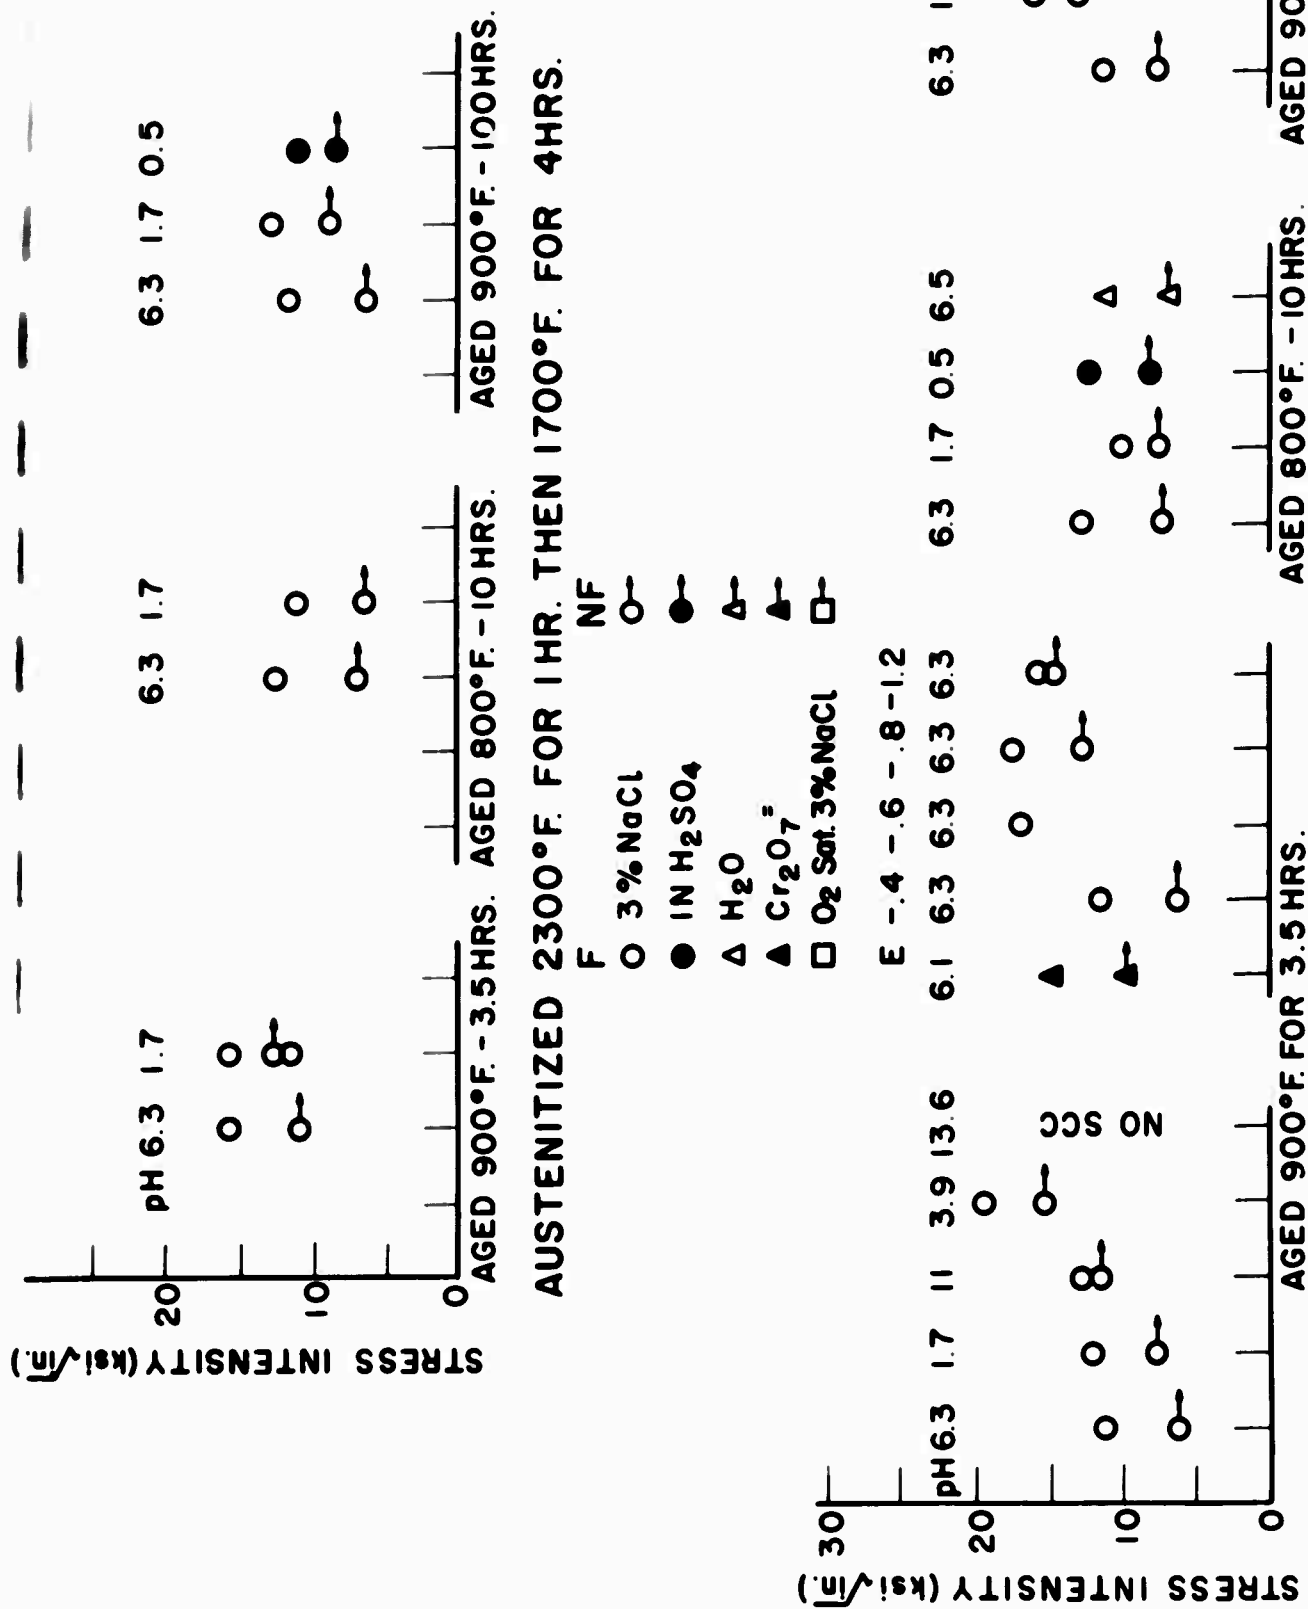
Fig. 10. K_{Iscf} of 18% Ni Maraging Steel in Various Heat Treated Conditions and Environments.

saturated 3% NaCl, and (c) in 3% NaCl + 1.5% $\text{Na}_2\text{Cr}_2\text{O}_7$ at pH 6.1. Figure 10 presents the threshold stress intensities obtained for all tests conducted. The value is always about 10-15 Ksi $\sqrt{\text{in}}$.
